Power Transmission & Distribution Fatality

Jon Fogleson, CHMM
OSHA Compliance Safety & Health Officer
Appleton Area Office

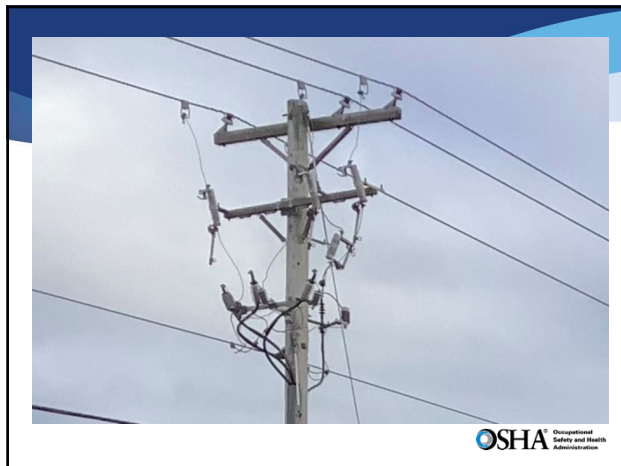
- At approximately 10:30 am, a plumbing contractor struck an underground electrical line with the bucket of his excavator.
- At 10:50 am, utility contractor employee (EE #1) arrived on scene and used his “hot stick” to open the three fuse disconnects on the overhead lines (approximately 7,200 VAC/line)

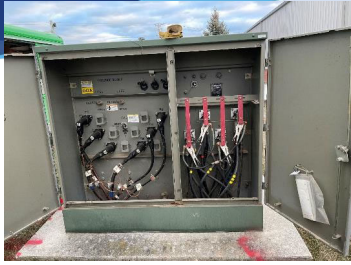
Transformer #1

Primary (Left side of T1)
Secondary (Right side of T1)

Left side of Primary (from power line)
Right side of Secondary (to T2)

Lines come in on left of Primary and goes out on right side of Primary (to Transformer #2)

- EE #1 called for additional response team members to assist in the repair of the line.
- EE #1 opened T1 and applied grounds to the secondary side going to customer #1, but not the primary side from the riser pole or the line to T2 that fed customer #2.
- Employees did not apply grounds to either side of T2.

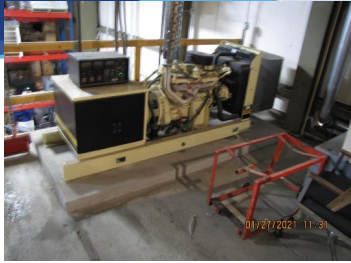
**Kohler 30 kW
Back-up generator**

Installed in 1999 for Y2K issues.

Connected to an automatic transfer switch to provide power to most of the building.

Load wires and line wires were reversed. When the switch was thrown, Power from the generator backed to T2 and then to the Supervisor working on the damaged line.
